Environmental exposure to asbestos fibres before and after removing asbestos cement roofs from two townships in Gauteng

Objective: The objective of this study was to measure asbestos fibres in the air before and after a large-scale removal of AC roofs, and to estimate levels to which members of the community might be exposed.

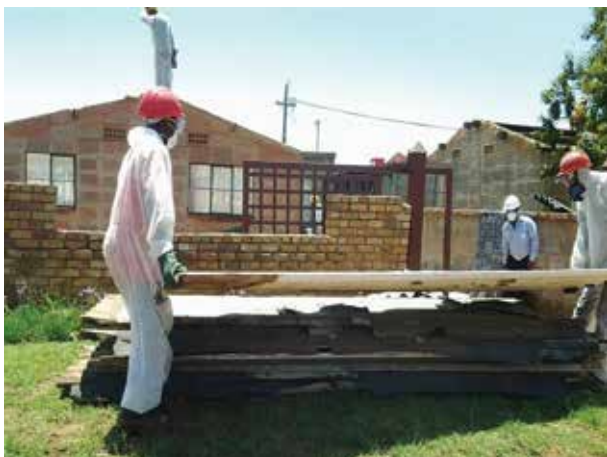
Figure 1. Asbestos contractors, wearing PPE, collect the removed AC roof sheeting before it is transported to a designated disposal site

A DoL-registered asbestos contractor (RAC) performed the removal and replacement of the AC roofs. The contractor's employees received training on asbestos work and were equipped with proper personal protective equipment (PPE), including disposable overalls and respirators (Figure 1). An attempt was made to minimise dust generation during the removal of roof sheeting: no high-impact tools were used and AC roofs were wetted before

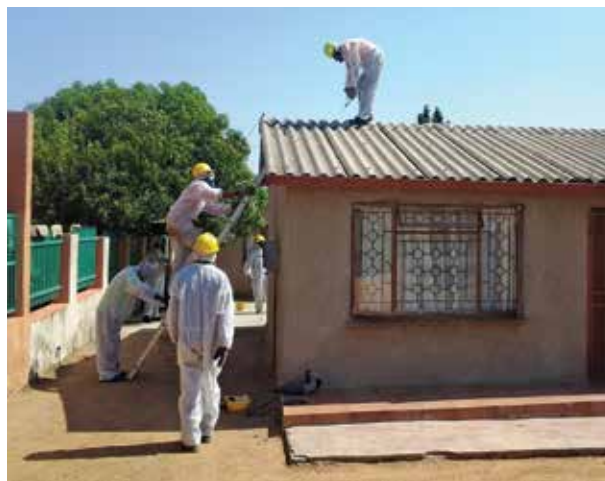
Figure 2. Bolts are loosened manually and AC roof sheeting is wetted before removal

removal (Figure 2). The AC roofs sheets were collected at a centralised location and cordoned off, before being transported to an approved asbestos disposal site.

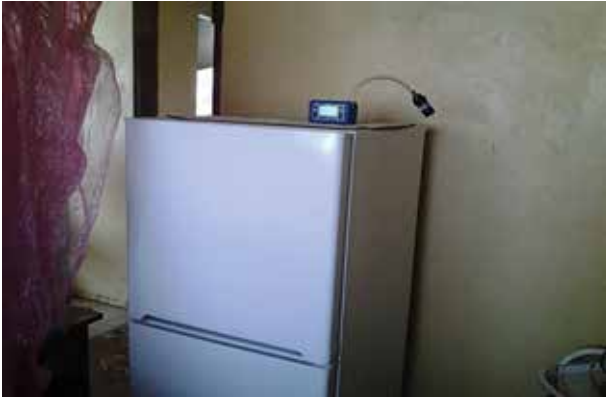
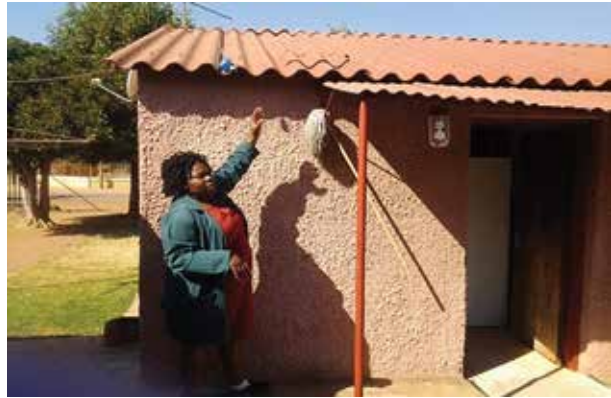
Figures 3 and 4. Typical asbestos sampling positions inside and outside the household

home, and at strategic locations inside the home (Figures 3 and 4). Measurements were taken before removal of the roofs during July 2014; and within 1-2 hours after removal of the AC roofs in November 2014 and February 2015. The sampling was conducted during dry (relative humidity 18.0%-55.5%) and warm-to-hot (280 °C – 330 °C) weather conditions. Wind direction varied and wind speed ranged from 0.1 metres/second to 1.88 metres/second.

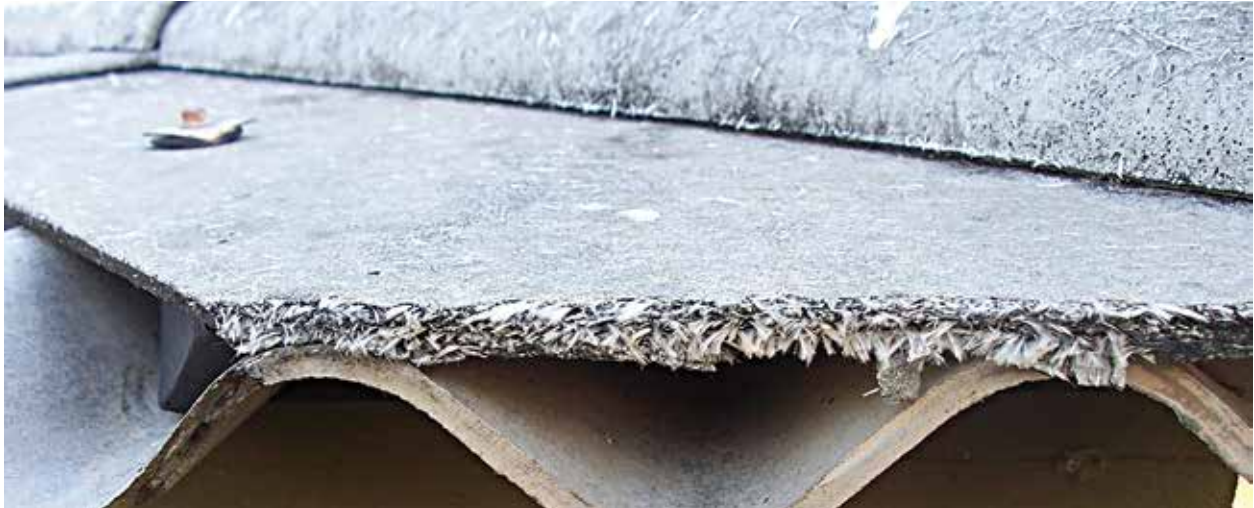
As AC roofs age and deteriorate, they will need to be replaced, raising concerns about their safe removal and disposal Photograph: Bill Bradley
